# Safety Inspection Report

Annual Inspection

## Worth Matravers

Worth Matravers Parish Council

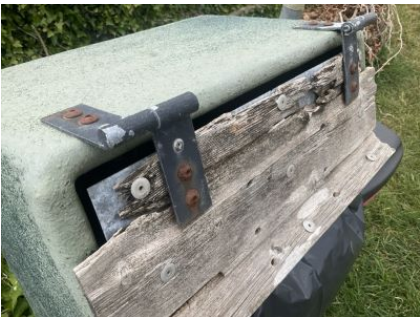
## Maintenance Finding

Description

Timber is decayed.

Tasks

Check on a routine basis.

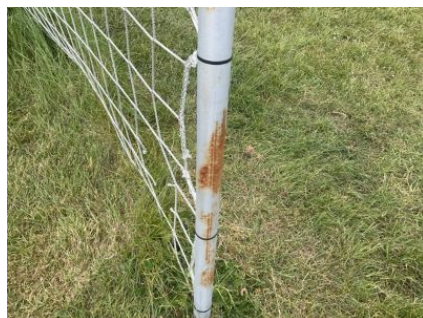
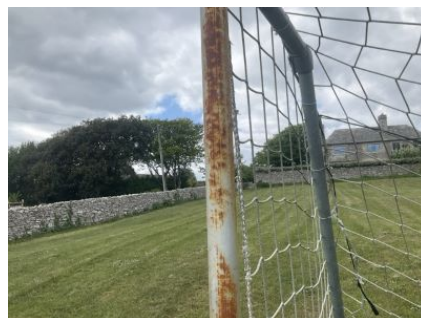
## Maintenance Finding

Item has corrosion.

Treat and repair.

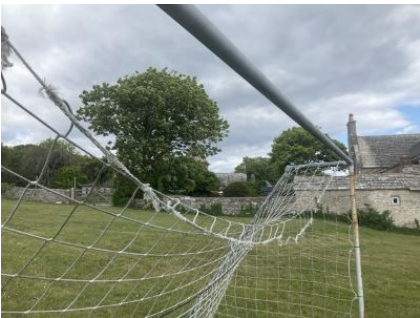
# Maintenance Finding

## Description

The netting is damaged.

## Tasks

Repair.

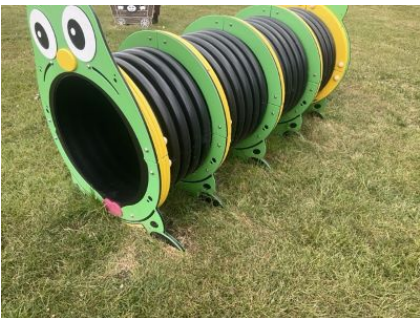
## Maintenance Finding

Description

Loose in ground.

Tasks

Monitor.

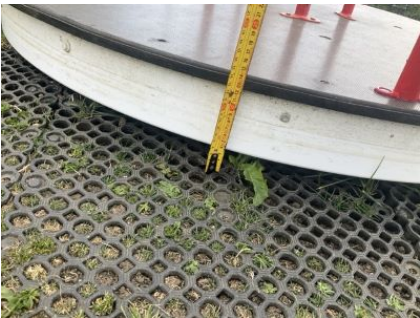
# Standard Compliance Finding

## Description

Clearance between the underside of the roundabout and the surface is incorrect.

## Note

Newly installed skirt less than 60mm, the gap needs to be between 60mm - 110mm. Previously was greater than 110mm, now less than 60mm.

## Tasks

Re-install roundabout or adjust surfacing. Recommended height 60-110 mm for 300 mm from edge.

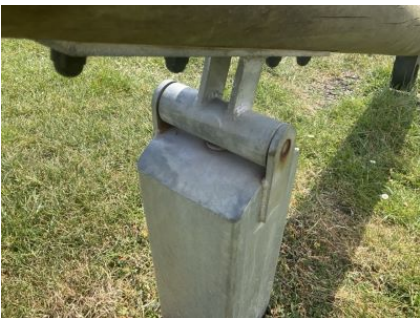
## Maintenance Finding

### Description

There is wear in the bearings.

### Tasks

Monitor and replace when necessary.

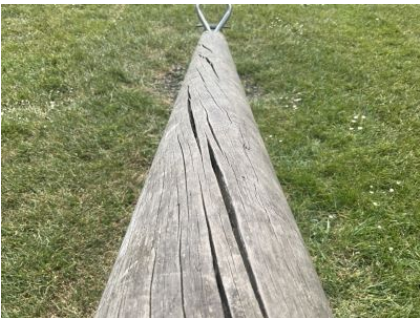
# Maintenance Finding

## Description

There are natural splits / shakes in the timbers.

## Tasks

DO NOT fill shakes. Monitor and sand back any splintered edges as required.

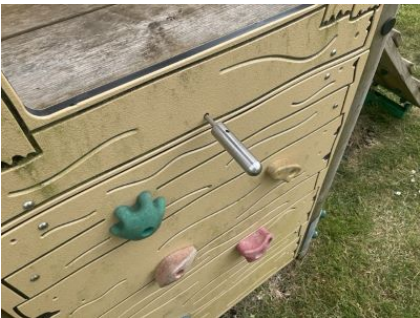
# Standard Compliance Finding

## Description

Finger entrapment.

## Tasks

Refer to manufacturer for comment., Eliminate the entrapment.

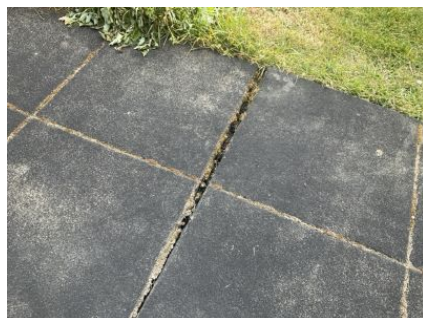
## Maintenance Finding

Gaps have opened up between tiles causing trip hazard.

Re-glue and fill gaps and joints as necessary.

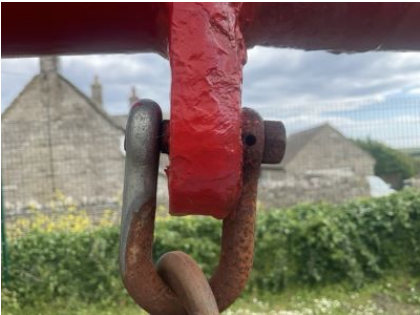
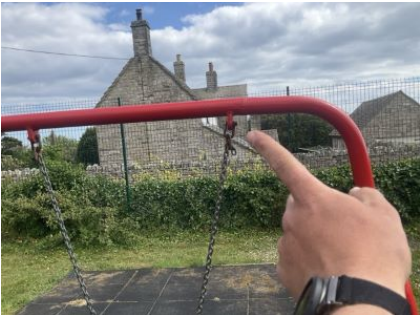
# Maintenance Finding

**Description**

Swing shackles or associated components are seized.

**Note**

Bolt seized so d-shackle rotating around bolt, opposed to bolt rotating in bush.

**Tasks**

Free off and check for damage.

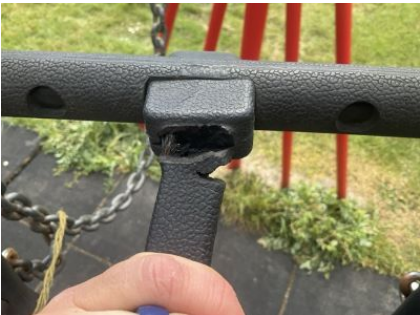
# Maintenance Finding

**Description**

The swing seat has been damaged, but does not require immediate replacement.

**Note**

Close to breaking. Replace strap.

**Tasks**

Read the notes for further action.

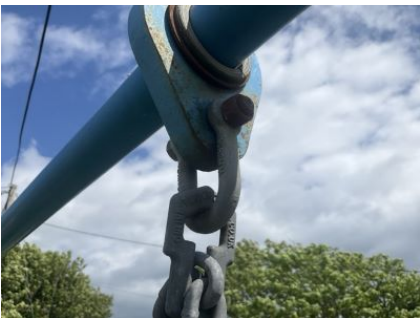
## Maintenance Finding

### Description

Swing shackles have been over-tightened causing them to jam.

### Tasks

Free off and check for damage.

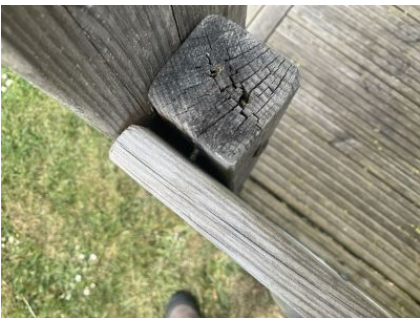
## Maintenance Finding

**Description**

Fixtures loose or missing.

**Tasks**

Tighten.

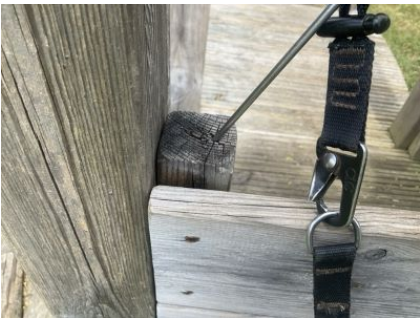
# Maintenance Finding

## Description

Timber is decayed.

## Tasks

Check on a routine basis.

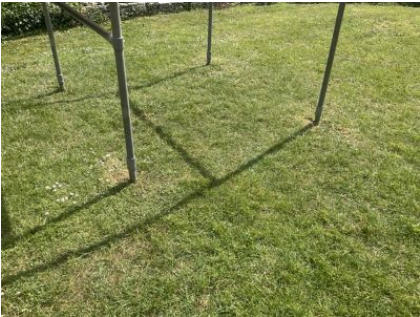
# Standard Compliance Finding

## Description

The critical fall height of the surface is less than the free height of fall of the equipment.

## Note

With a free height of fall of 2 m, this unit needs to have an impact attenuating surface underneath. Well maintained grass only provides adequate impact attenuation for falls of up to 1.5 m.

## Tasks

Modify.
